# Review

Sample Site, Sample Street, Anytown, UK

**Reference:**  
Sample\_Review\_171025

**Date:**  
17 October 2025

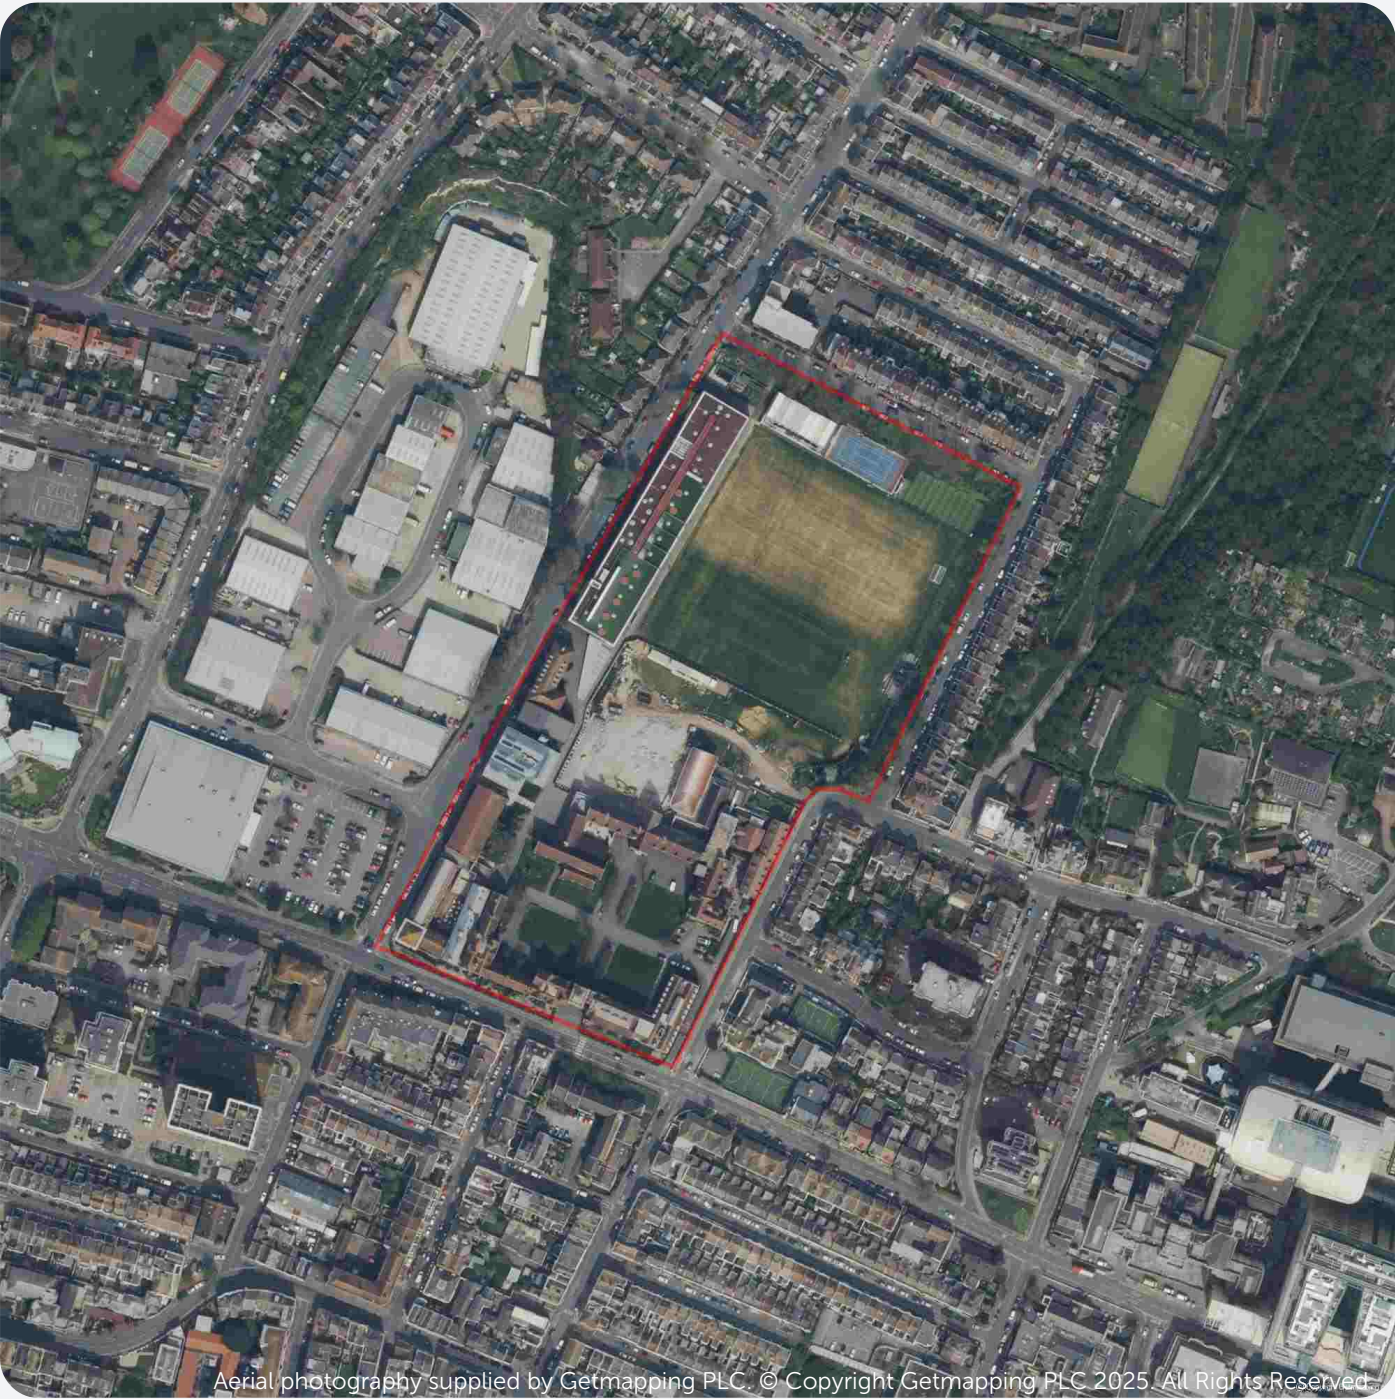
Recent aerial photograph

Capture Date: 17/04/2022

Site Area: 4.69ha

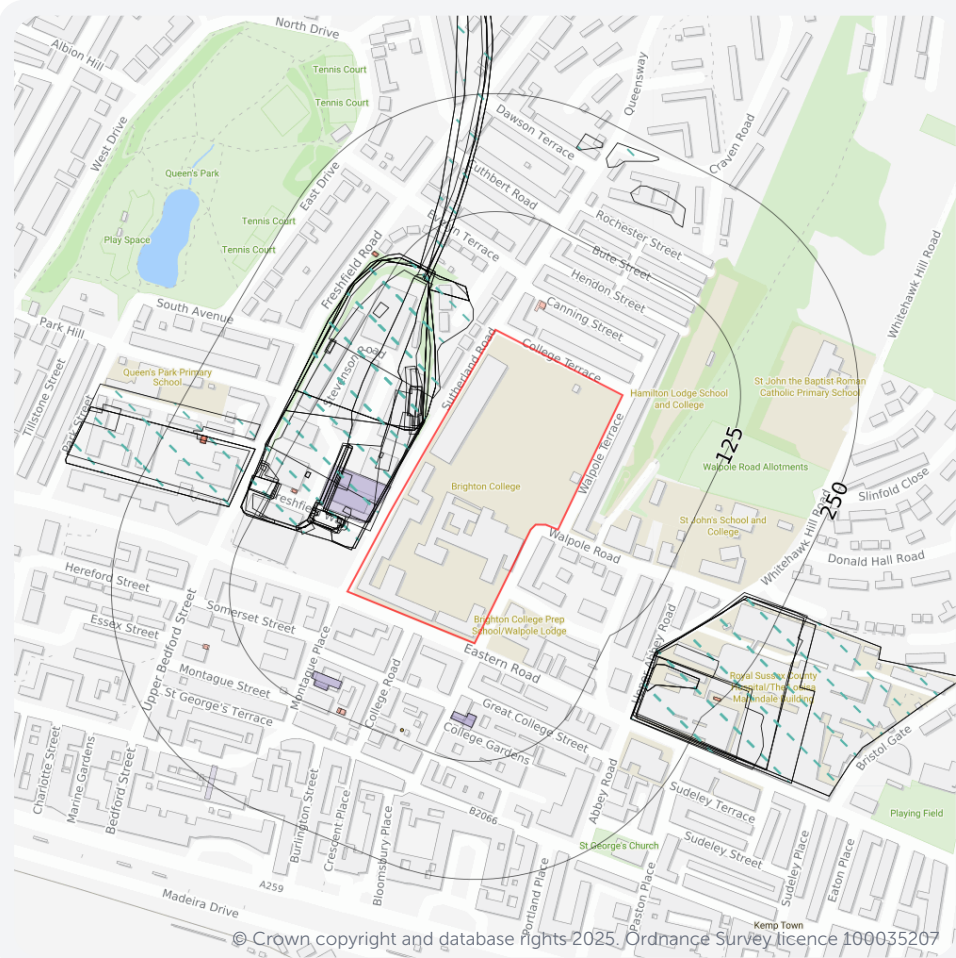
The data summarised in this section relates to potentially contaminative land uses and operations that happened historically at and around the site.

These historical land uses have been identified from 1:10,560 and 1:10,000 scale Ordnance Survey maps dated from the mid to late 1800s to recent times. They have the potential to have caused ground contamination. Please see the Environmental Summary to find out how these could impact the site.

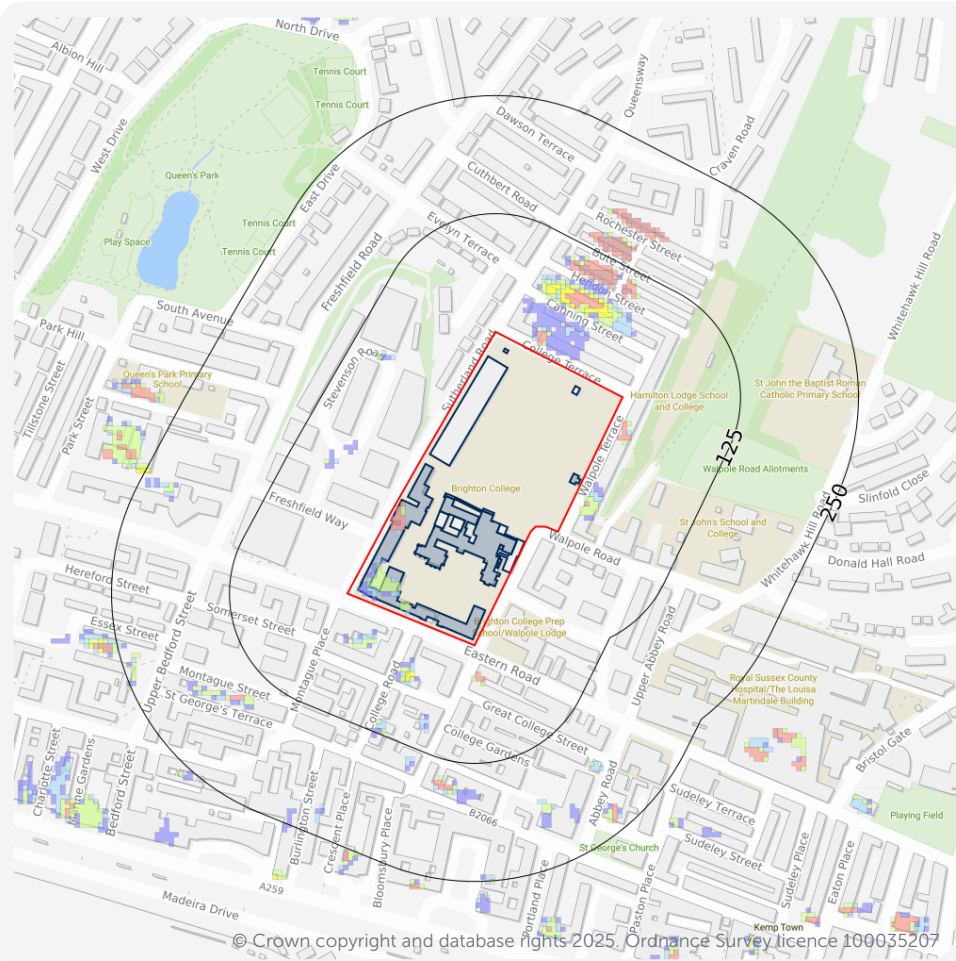
A highly significant risk of surface water flooding has been identified at a building/structure level. Heavy rainfall may overwhelm drainage systems, leading to repeated disruption and damage. This may be relevant for insurance or site management. Please see the recommendations on [page 21](#) → for further information of what to do next.

- We understand that the property has a basement, as such this is an additional entry point for flood waters and could increase the severity of any damage caused. We recommend seeking specialist advice on ways to mitigate or reduce the ingress of water;

- Ensure buildings and contents insurance covering flood risk and business interruption is available and affordable;
- A risk of groundwater flooding has been identified at the site. This will be more of an issue for properties with a basement or other section below ground. Further guidance on groundwater flooding has been produced by the Environment Agency and can be found at <https://www.gov.uk/guidance/groundwater-flooding>;

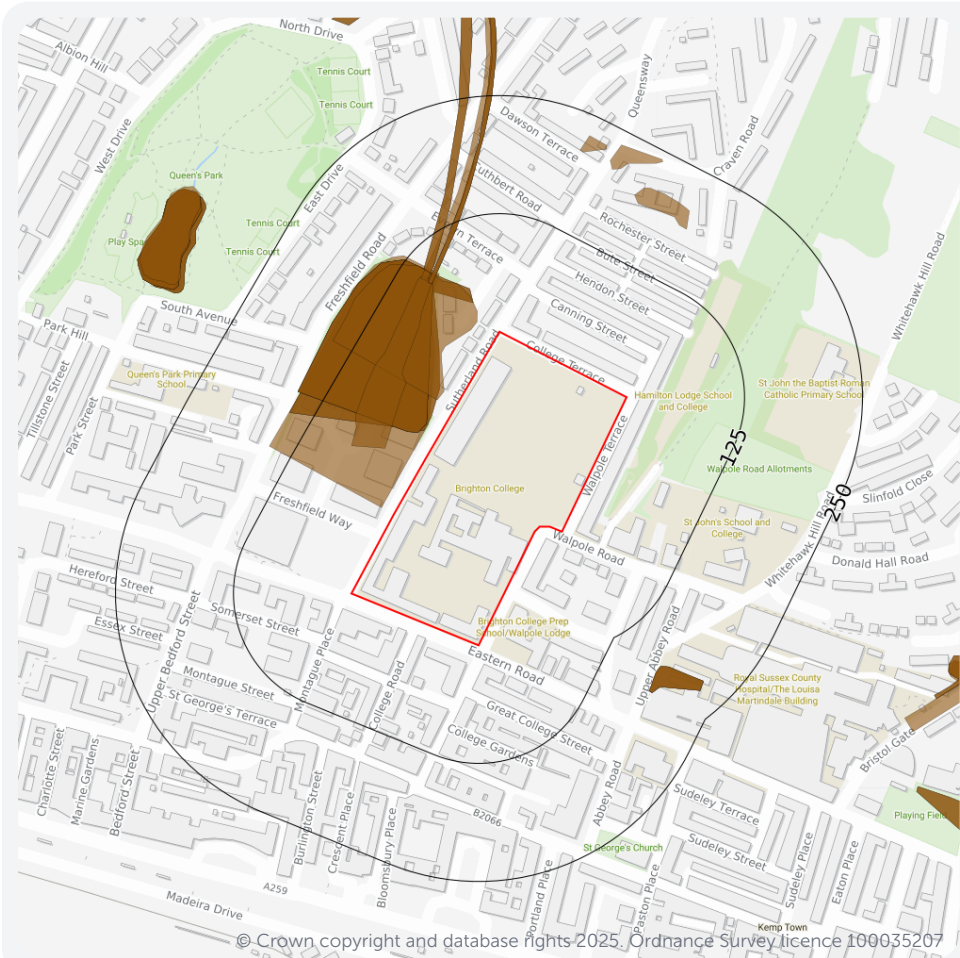
The property is located in an area that may be affected by surface or sub-surface mining of materials other than coal. Mining may cause ground stability problems such as subsidence, surface collapses, mass movement and landslides, depending on the style of mining used.

Maps suggest the property is located near a previous pond, quarry, mine, landfill or other hole in the land. These land cavities are often filled with various materials, and this can cause structural problems. Groundsure's experts recommend that you check whether your structural surveys have taken this into account.

- if a survey has been undertaken at the property that considers ground instability and no issues were found, no further action is required
- however, based on the findings of this report, the purchaser should be encouraged to consider potential instability in any future development or alteration of the ground including planting and removing trees, and regardless of the survey outcome
- if no survey has yet been undertaken, we recommend one is carried out by a suitably qualified and experienced person
- if ground instability issues have been or are subsequently identified in a survey we recommend following any advice given in the survey findings

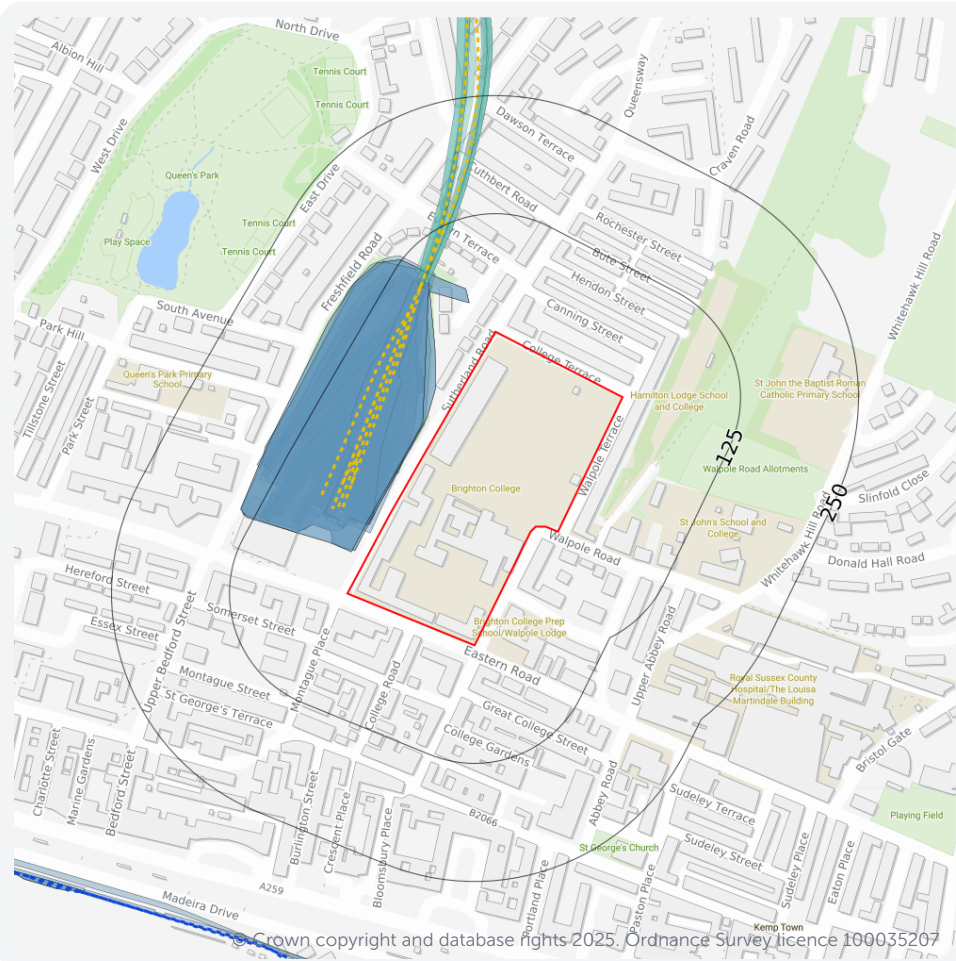
The property is situated within 250m of a railway or tunnel feature identified on historical mapping. Please note that many historical railways noted in this section will still be in use today.
